# TEADIT<sup>®</sup> 24SH – Spiral Heat Exchanger CASE HISTORY

## INDUSTRIAL SEGMENT

Biochemical

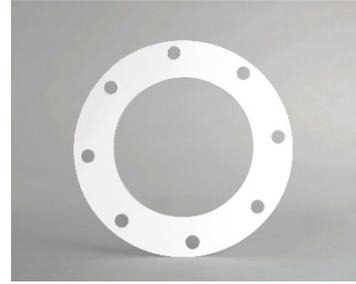
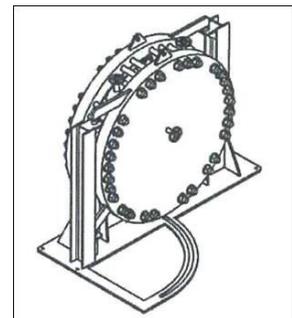
A biochemical manufacturer reached out to TEADIT's partner for support regarding premature gasket failure on a spiral heat exchanger. Spiral heat exchangers pose some unique challenges for sealing due to their very large diameter as well as their unique sealing surface. The special flange design found on this type of equipment can often lead to large flange irregularities which require a soft gasket capable of compensating for them. The customer was currently utilizing a compressed fiber sheet product composed of synthetic fibers with an HNBR binder, as well as applying a silicone adhesive product with the objective of aiding in installation and improving sealability. This solution lasted only three to four months in service and required a large installation effort which led to a prolonged shutdown for each failure. After a thorough review of the application it was determined that the customer was experiencing premature failure due to the gasket material not being able to compensate for the flange irregularities in the equipment and their use of a silicone adhesive which can be detrimental to proper gasket seating.

The customer contacted Teadit's application engineering team to help them find a solution to this application. After a thorough investigation of the application it was determined that a softer material was needed that was able to compensate for the flange irregularities. Teadit recommended the customer switch to ¼" (6mm) thick 24SH material due to its high compressibility and its ability to overcome flange irregularities. It was also critical to find a

solution that would aid in the installation effort in order to eliminate the need for the use of the silicone adhesive. In order to overcome this challenge, the gasket was designed with a few bolt holes to help position the gasket and aid in the installation effort.
