TEADIT® 2773/2202 for Pumps in the Sugar Industry CASE HISTORY

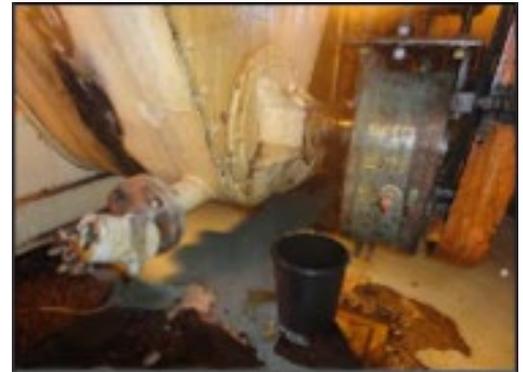
A world leader in the agribusiness industry began experiencing excessive leakage of products and by-products, as well as having multiple pump failures all due to abrasive media and the wrong installation of material. They were spending excessively for maintenance cost, material loss, equipment damage and cleaning all while intaking high amounts of water consumption. They needed a resolution quickly.
