TEADIT[®] 24B CASE HISTORY

Flue Gas Desulfurization

Flue Gas Canal

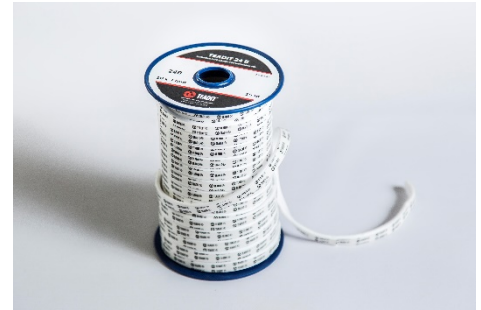
Halar-coated steel flange connections were unsuccessfully utilizing an ePTFE gasket tape and experiencing leaks. The end user was perplexed by the issues because they knew that the ePTFE material was chemically resistant to almost any process media and was often recommended for flanges like the halar-coated steel that require careful handling and low stress to seal materials. Upon opening the flanges it was immediately apparent that incorrect installation methods, combined with a low quality tape, which was also too thin, led to the leaks and also contributed to some identified flange damage.

Teadit 24B joint sealant was recommended and Teadit field and technical support offered to work directly with maintenance personnel during shut down to provide training and oversee the installation.
