# Case Study: Optimizing Heat Exchanger Performance With Reliable Gasket Solutions

BY FRANCISCO DUQUE & ANGELICA PAJKOVIC

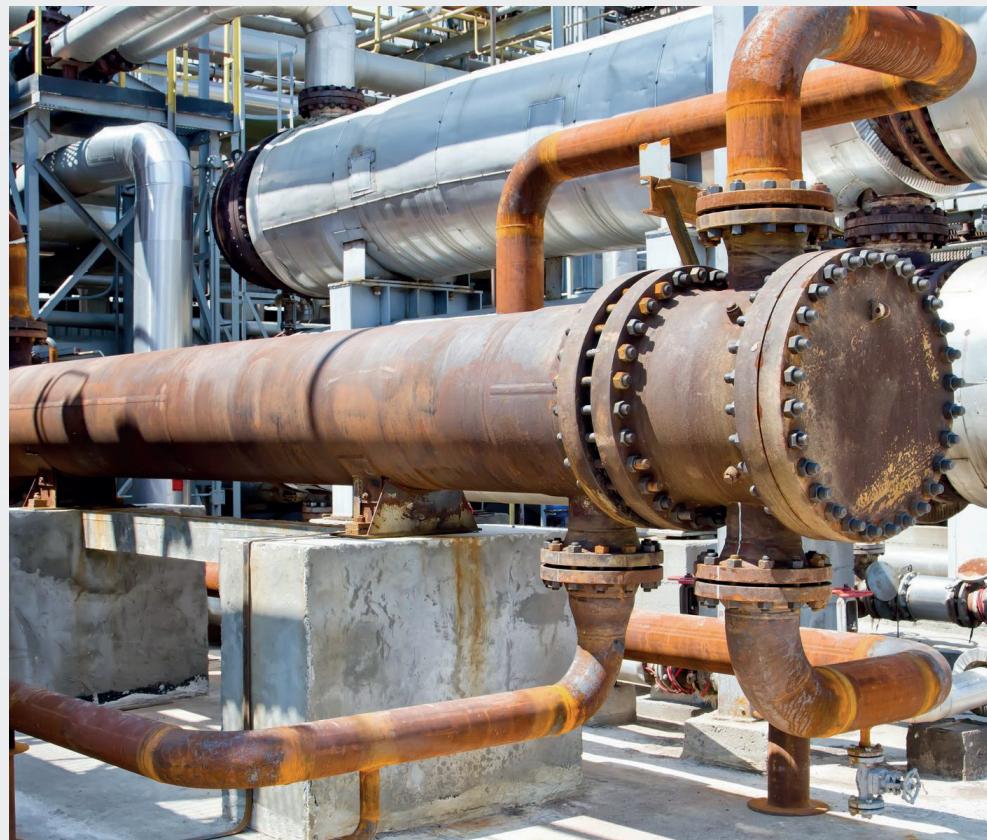
Example of a heat exchanger used at a chemical plant.
