# TEADIT<sup>®</sup> Camprofile in Chemical Processing

## CASE HISTORY

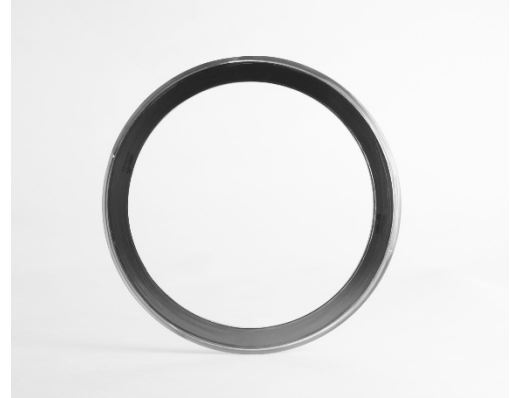
A PTFE manufacturing facility was experiencing leaks on an FEP Extruder that was originally designed to utilize a metal reinforced compressed fiber gasket. Their existing configuration was resulting in significant polymer losses of nearly 90lbs per hour. In addition, the leakage issues necessitated regular maintenance which cost them 2 hours of downtime. Once repaired and restarted, the leakage issues would reappear within the hour. This issue had progressed to the point that the equipment was nearly inoperable.

Teadit's technical team assessed the issue and determined that the best course of action would be to switch to a Camprofile style gasket which features a solid metal core faced with a flexible graphite sealing element. To ensure optimum sealing, some minor work was done to the flange sealing surface to accommodate the requirements of the new gasket. Additionally, installation training and instructions in accordance with the recommendations of ASME PCC-1 were provided to the installers.

Once properly installed, the Camprofile gasket showed no signs of leakage after a month in service. The savings from lost product, downtime, and maintenance costs was over \$21,000 per month.
